Architectural & Historical Report

**The Siasconset Public School
The Siasconset Fire House**

**10 West Sankaty Road
Siasconset, Massachusetts**

October 15, 2019

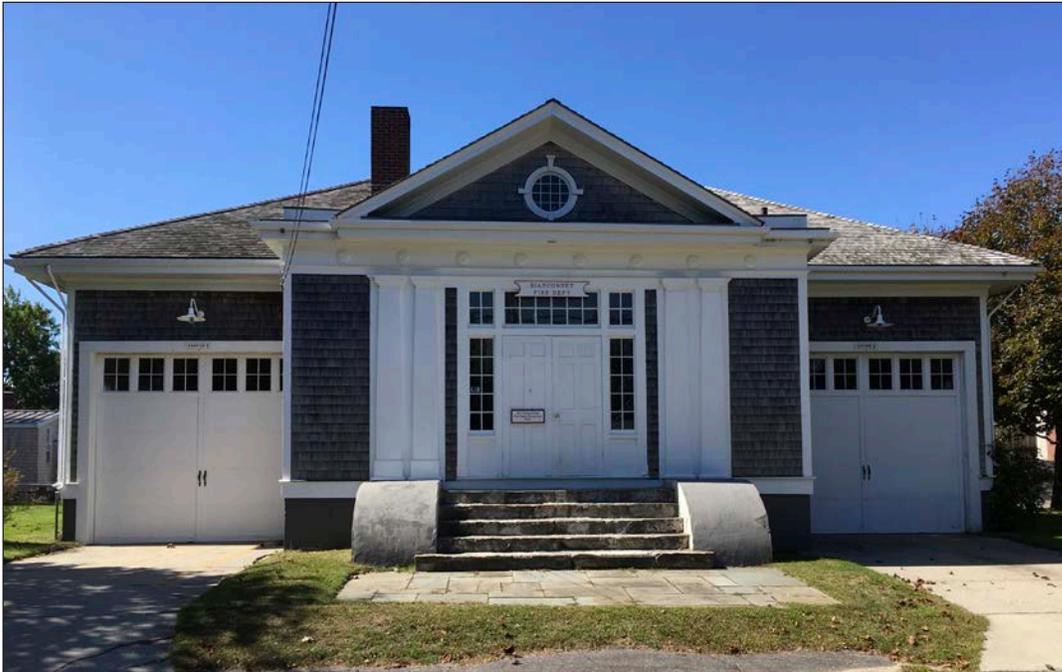
Front east entry elevation showing ca. 1965 addition of fire truck bay doors

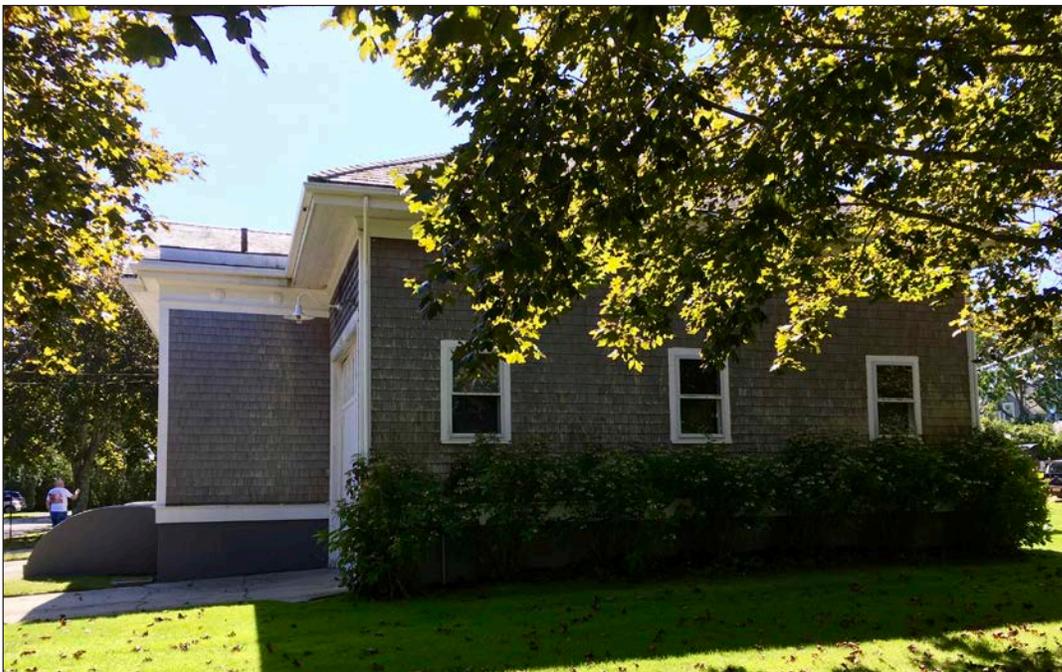
North Elevation showing (3) windows that replaced the original (7) 12/12 windows

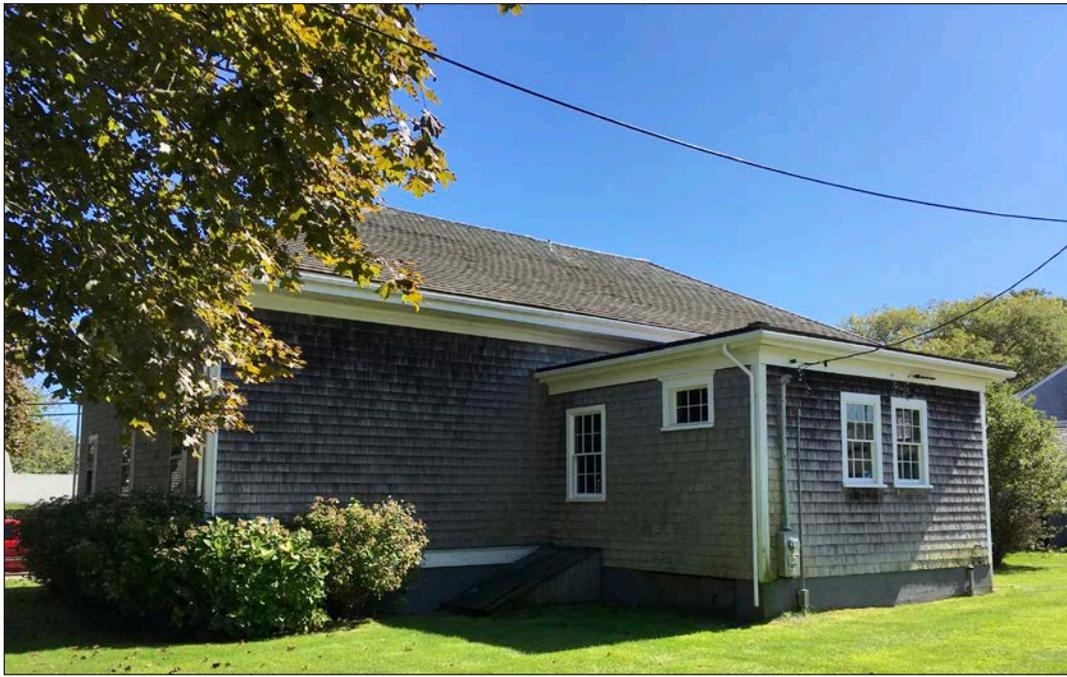
North side of the west elevation

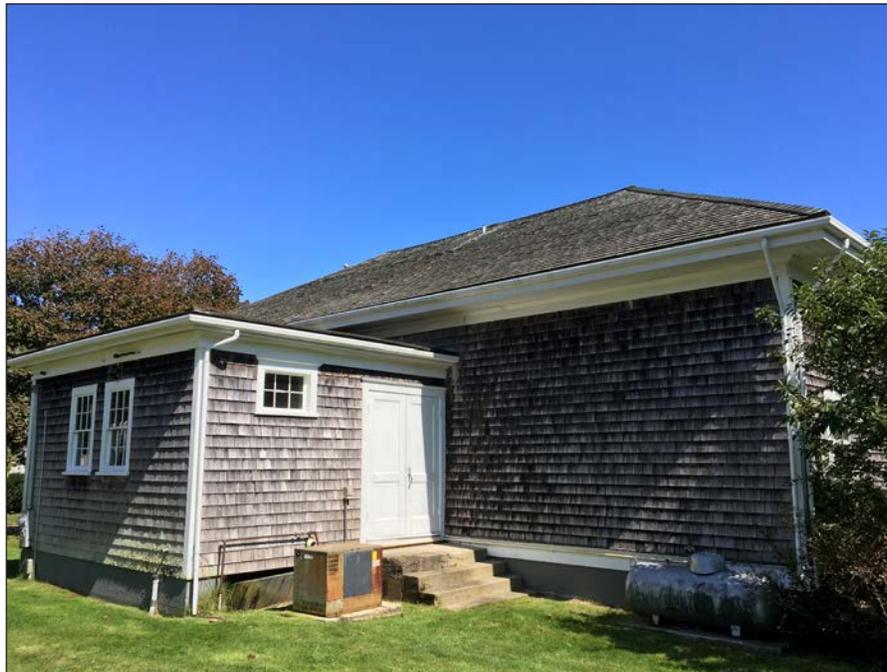
South side of the west elevation showing
early double doors

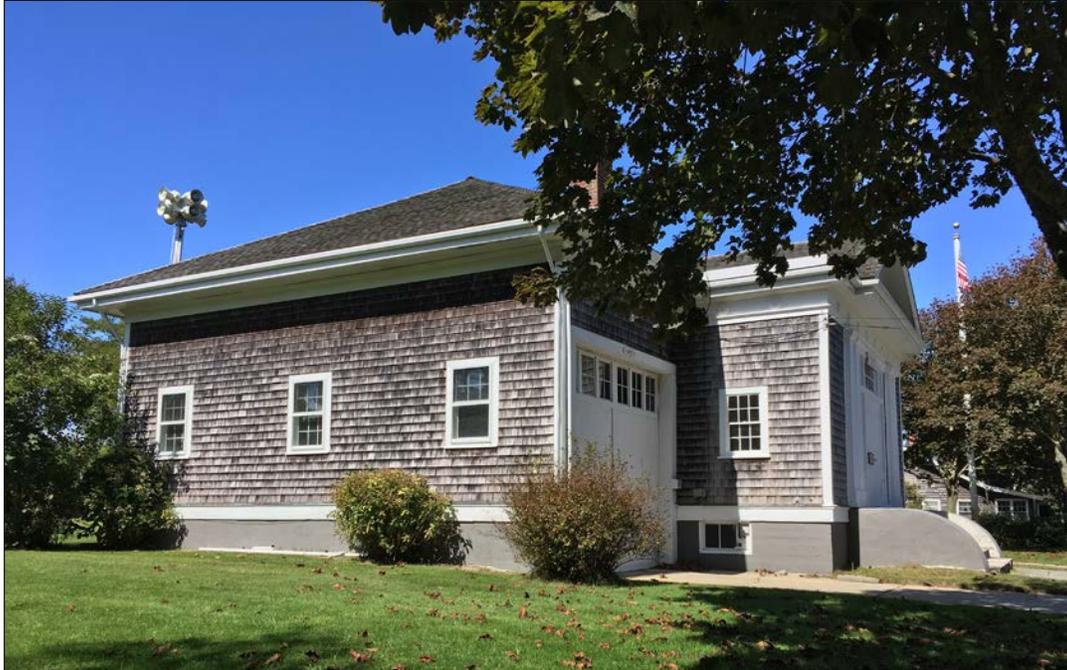
South Elevation showing (3) windows that replaced the original (7) 12/12 windows and the front east entry elevation showing the ca. 1965 fire truck south bay

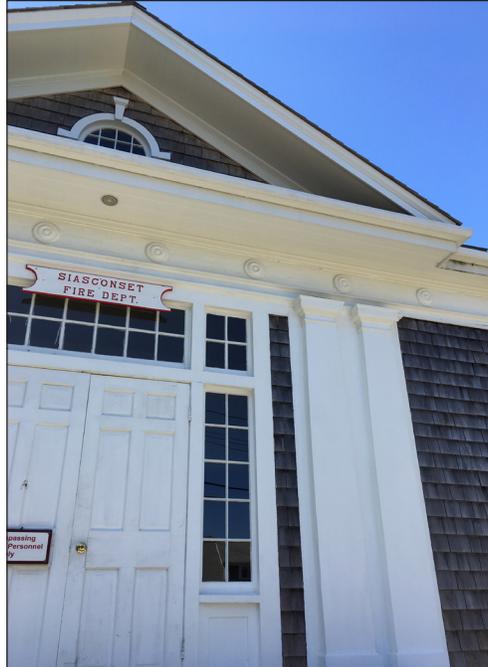
East Front Elevation Detail of classical pilasters, sidelights, transom, pediment and round window

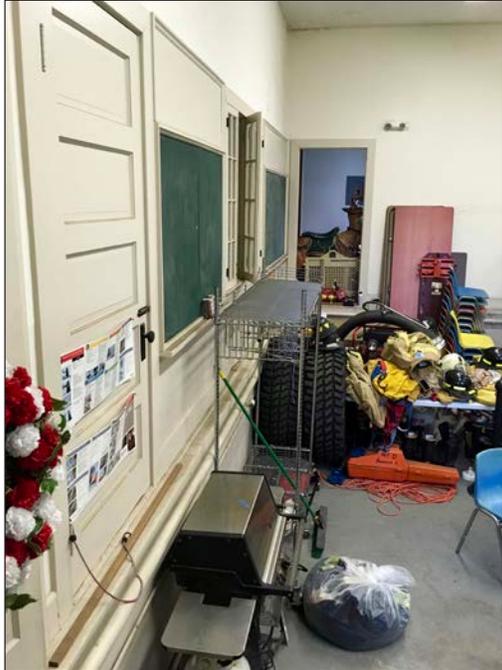
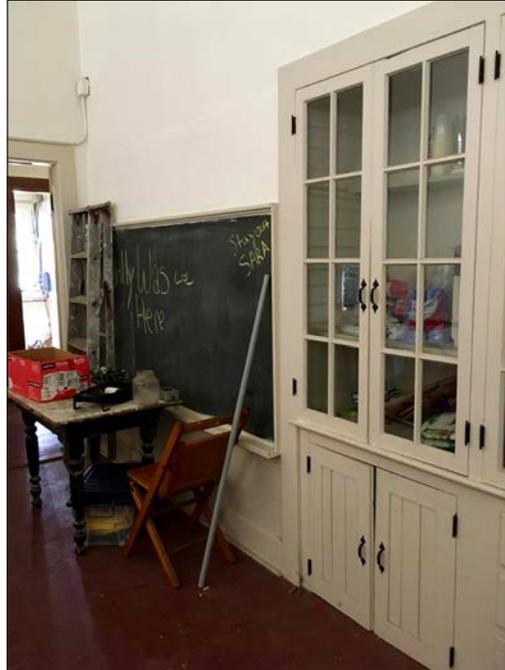
Original Interior Classroom Built-in
Cabinets & Blackboard:
North & South Classrooms
